# ETHILON, INC.

SEVEN YEAR DATA FOR TEN YEAR PROLENE™ STUDY: ERF 85-219  
-----

This report contains a summary of IR, IV, GPC, OM and SEM data supporting this study.

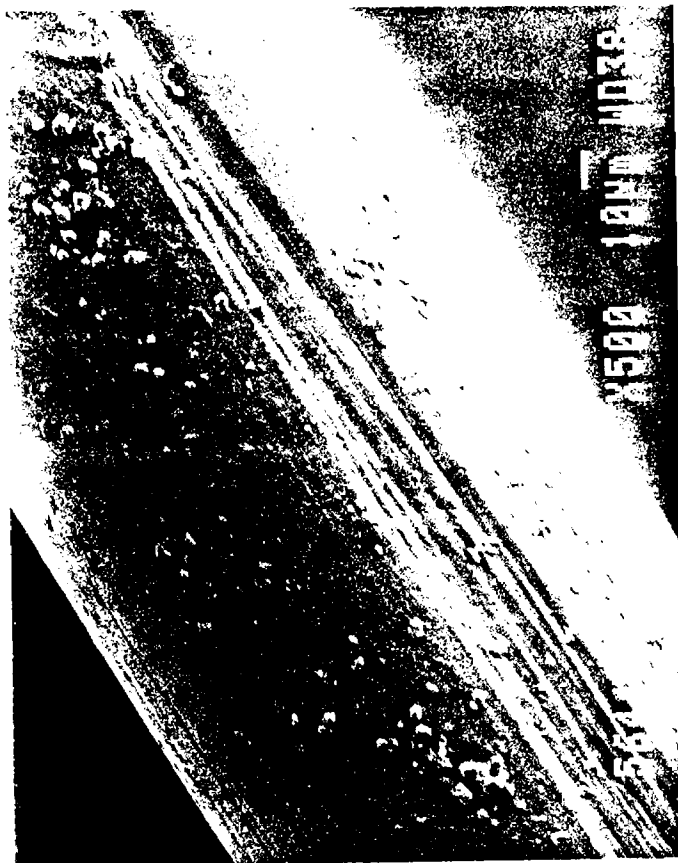
Figure 5 7 Year PVDF Explants

In Figures 5 and 6 the SEM examination of the PVDF sutures is shown. Only on the suture from one site (Figure 6 site 6) some cracks are found. The surfaces of the sutures from the other five sites show some striations which could be mechanical damage, otherwise the surfaces look intact. The contaminant on the site 4 (Figure 5) suture is tissue which had not been removed completely.
